Ventilation Strategies in Greenland

By Martin Kotal and Eva Møller, Technical University of Denmark, Denmark

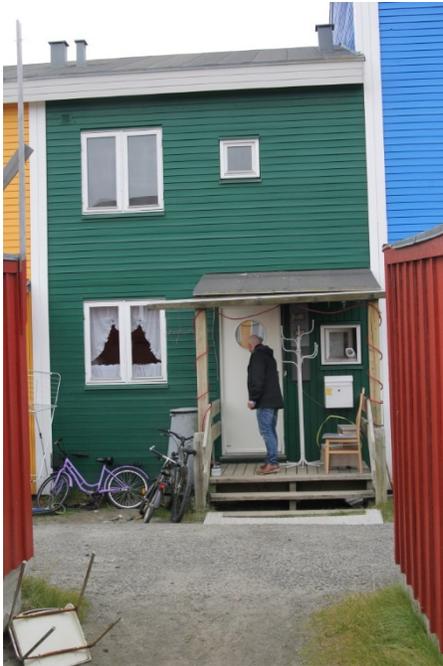
Figure 1. Building 1 – view

This building is a type row house in Tuapanguanut – Sisimiut built in the 1980s (Figure 1). It consists of two floors. In a ground floor there is an entrance, laundry, living room, and kitchen. In the second floor there are two bedrooms and a bathroom (see the floor plans in Figure 2). The floor area of the home is approximately 70 m². The house is occupied by a family of seven (two adults and five children). The original ventilation system consisted of fresh air valves (FA) in bedrooms and living room, range hood, and two vertical ventilation shafts from bathroom and laundry room (EA) (see Figure 2).

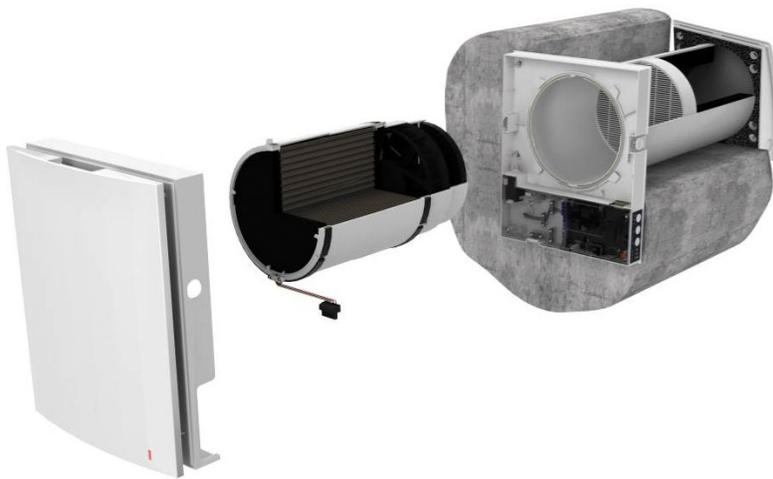
Figure 8. Schematics of the decentralized ventilation unit

In this case, the renovation consisted of installation of four decentralized (one-room) ventilation units (VU) in the façade (Figure 8). Existing fresh air inlets were used to accommodate the new ventilation aggregates (Figure 7). The existing range hood and natural ventilation shaft in the bathroom remained unchanged.

The ventilation units run in two cycles. Cycle 1 – the built-in ventilator blows the fresh air into the building. Cycle 2 – The direction of the fan changes and air is extracted out of the building. The cycles switch at the interval of 70 s. Inside the device, there is a ceramic-based element that acts as a heat and moisture recovery. It accumulates heat and moisture of the extract air (during cycle 2) and reintroduces it to the fresh air (during cycle 1). To maintain pressure balance inside the house, the four units are synchronized in a way that when two of them run in cycle 1, the other two run in cycle 2.
